## ADDING VALUE

### 3D-PRINTED METAL PART

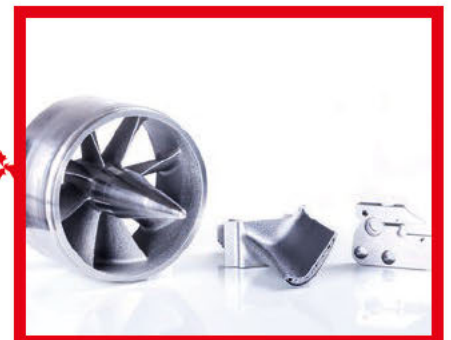
3D printing is creating components in a range of industries including aerospace, medical, and power generation.
