DOWN TO EARTH

MUD ROTORS

BODYCOTE COMPONENT JOURNEYS

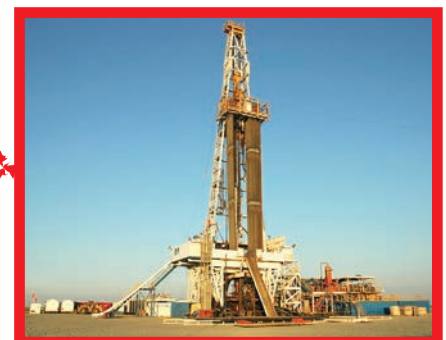
End application – oil drilling service.

Corrosion and wear can lead to expensive downtime in oil & gas exploration, where equipment is in continual use. Mud rotors operate at the bottom of drilling wells, thus, the removal and replacement of worn rotors is particularly time consuming and costly. Following processing by Bodycote, the life of mud rotors is improved significantly.
